**O & M INSPECTION REPORT
FOR NAVIGATION AND SHORE PROTECTION PROJECTS**

1. Project Name: Nawiliwili Small Boat Harbor

2. Date of Inspection: 06 Sept. 2002

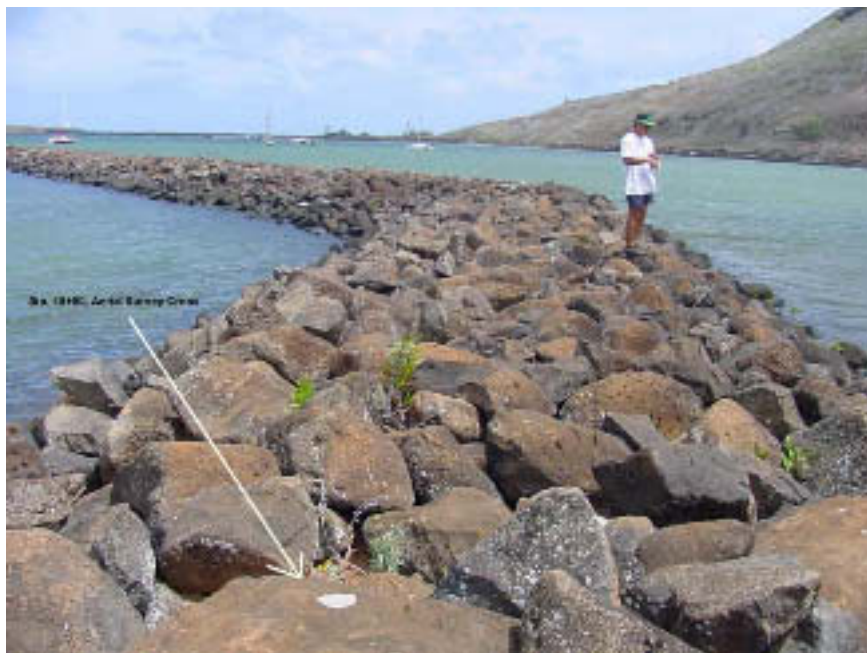
b. *Sta. 19+00, Aerial cross

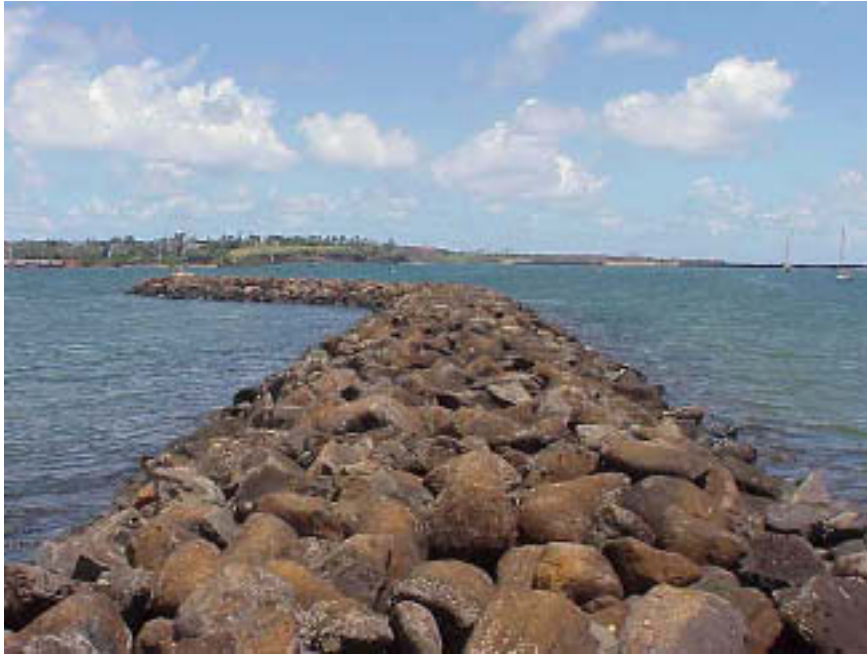
c. Sta 19+60: Overview to end.

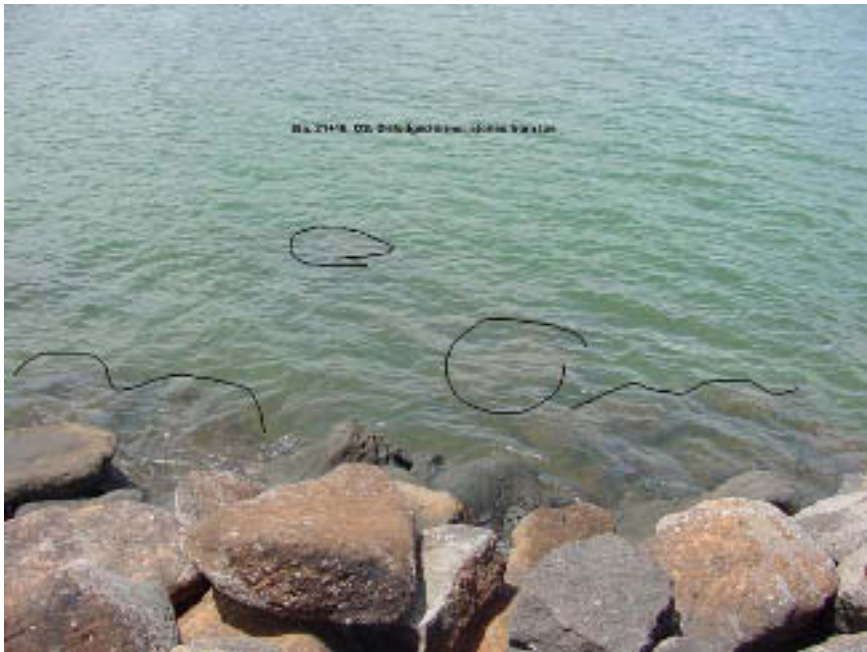
d. *Sta. 21+16, OS, several armor stone resting approx. 3-4 ft. from toe of breakwater.

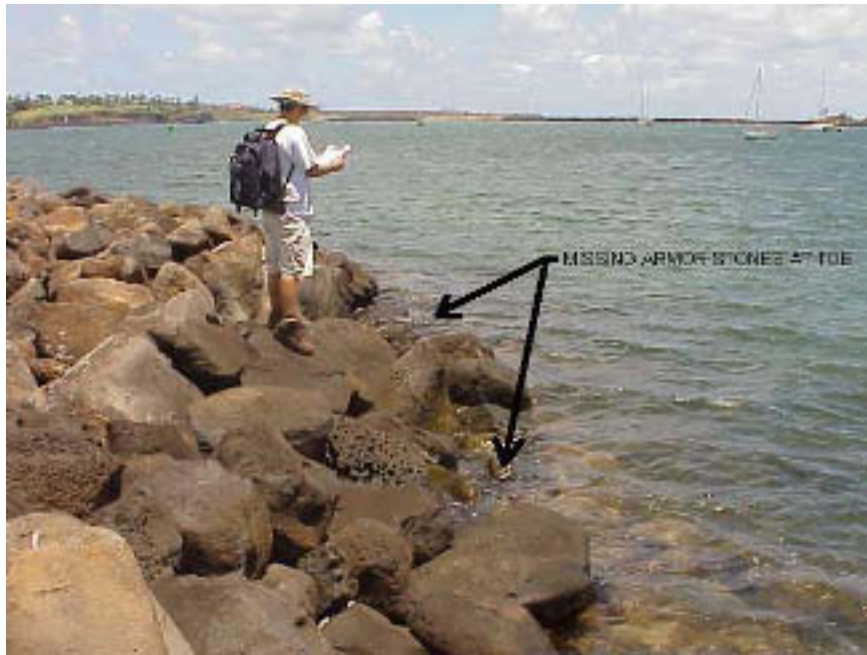
e. Sta. 21+56, OS , several missing armor stones at toe.

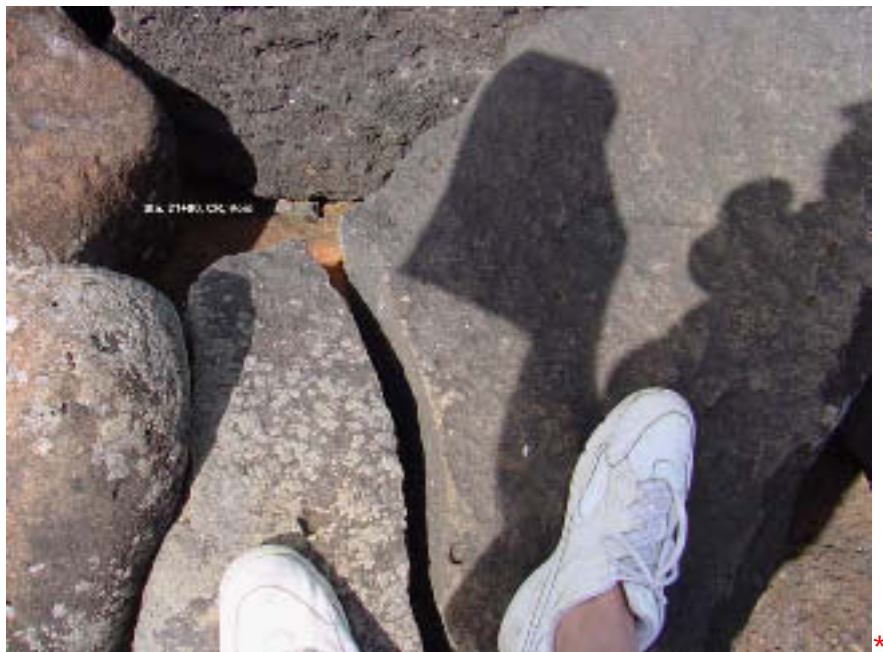
f. *Sta. 21+80, cracked armor stone at CL of crest and void.

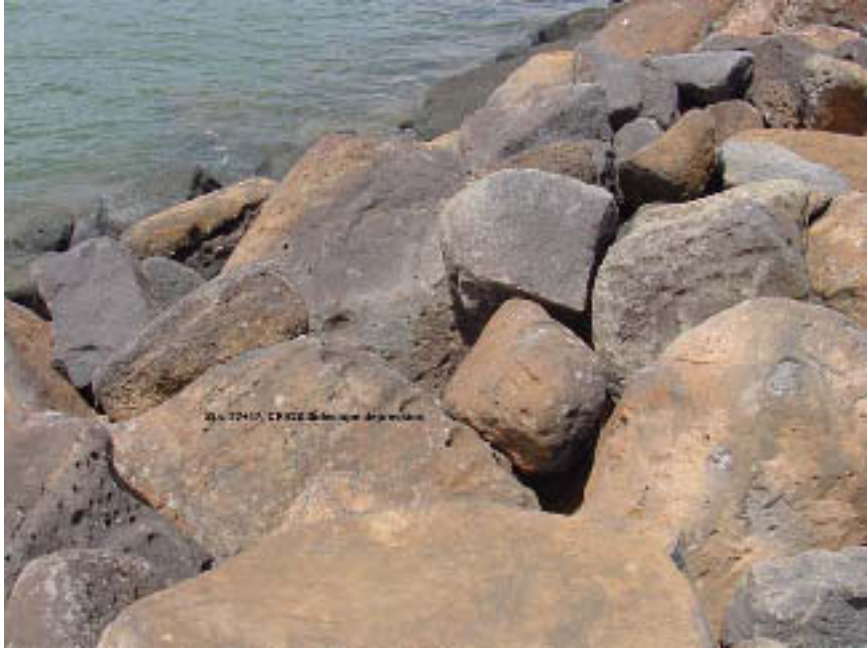
g. *Sta. 22+17, Crest, (CR), 2x3x3 depression at the OS hinge --possibly the result of poor construction.

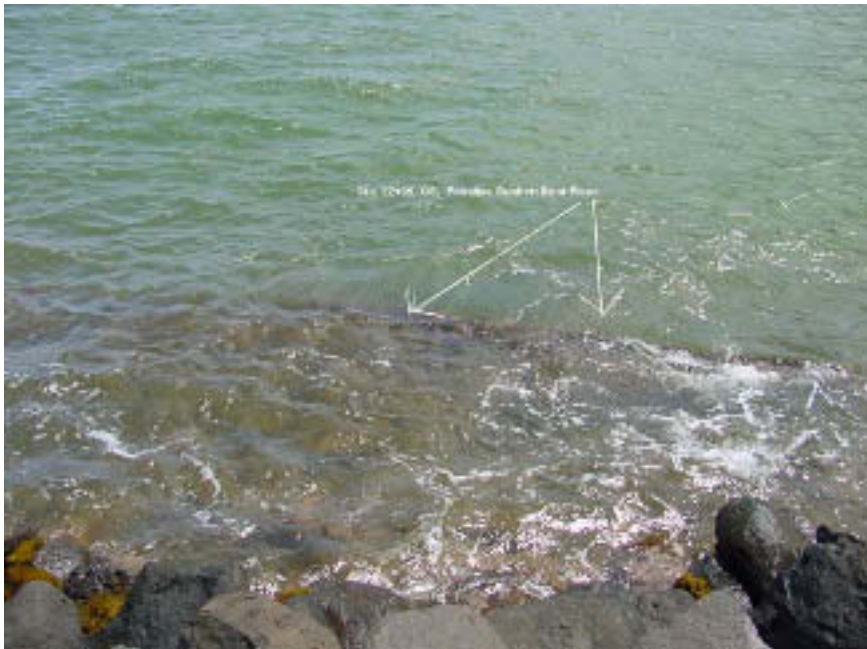
h. *Sta. 22+35, OS, possible location of sunken sailboat, appears to have moved from previous inspections.

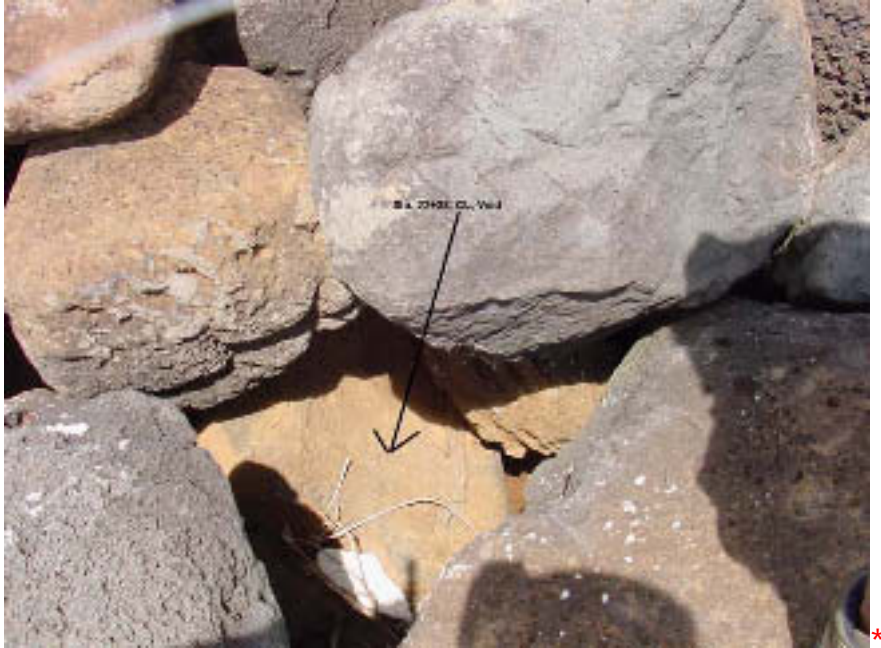
i. *Sta. 22+38, CR, 2x4x2 deep void--possibly the result of poor construction.

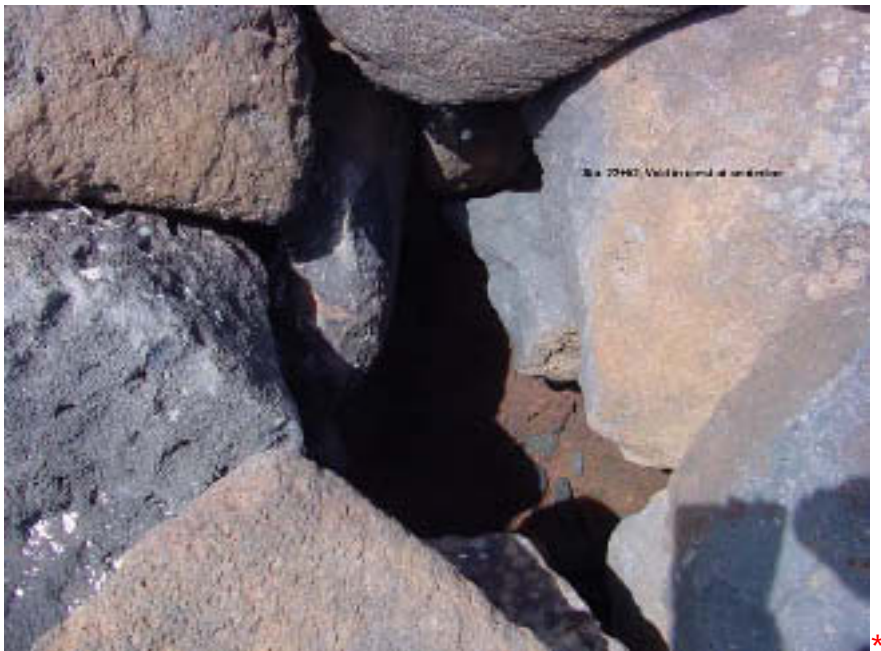
j. *Sta. 22+52, CR, 2x4x2 deep void--possibly the result of poor construction.

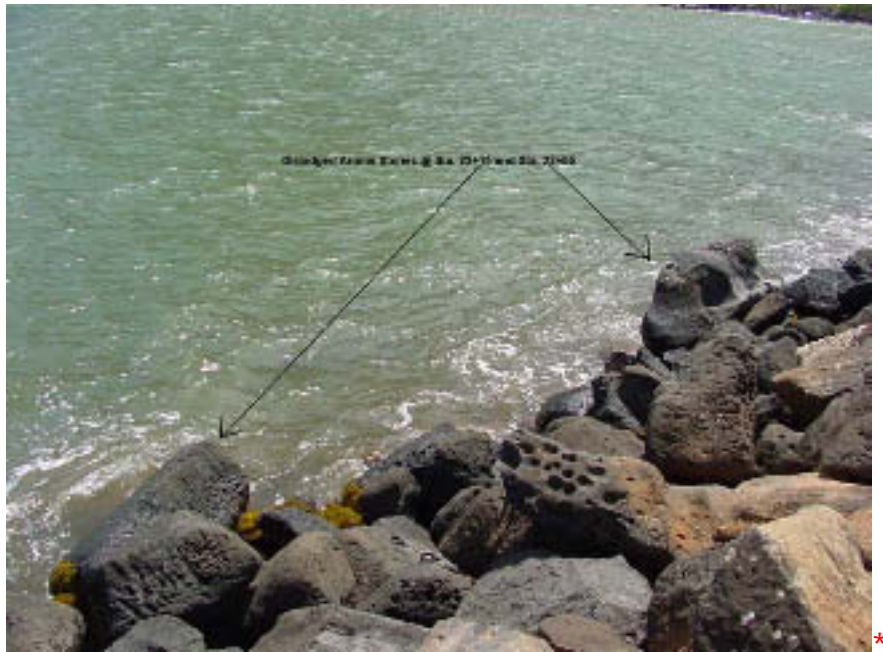
k. *Sta. 22+95 & 23+15, OS, 2 dislodged armor stones at the waterline.

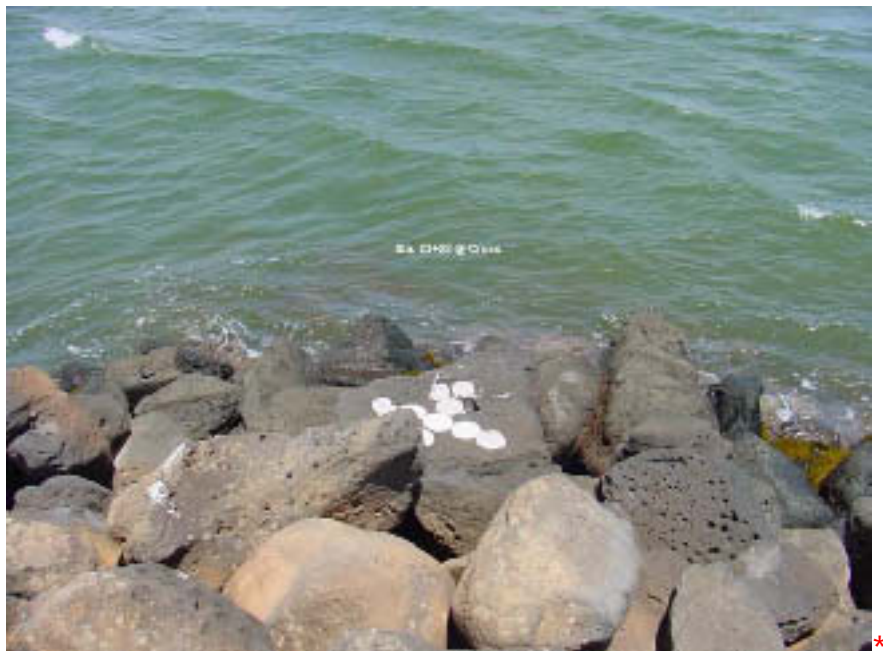
l. *Sta. 23+38, Overview of head and aerial survey cross.

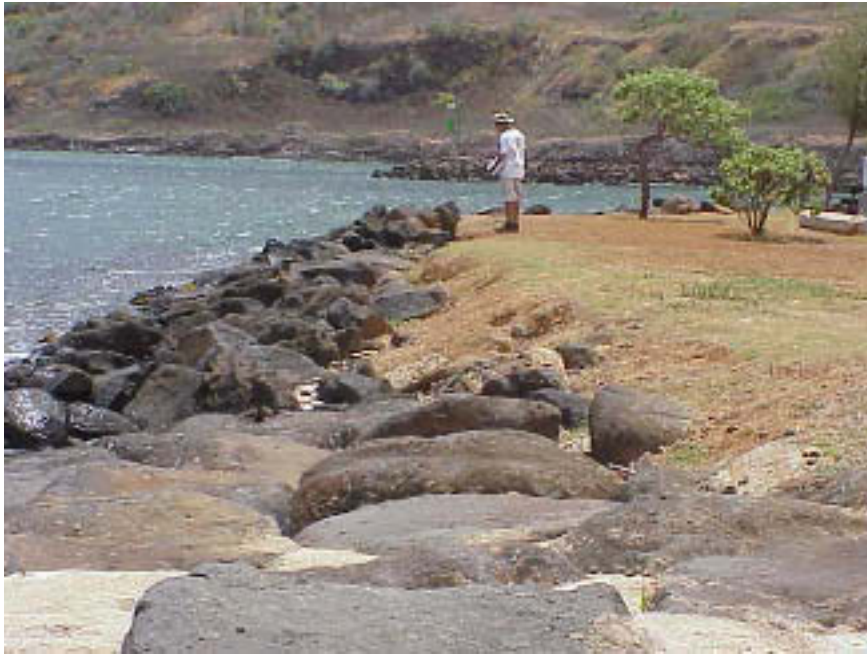
a. Overview from Sta 0+00 to Sta 1+00.

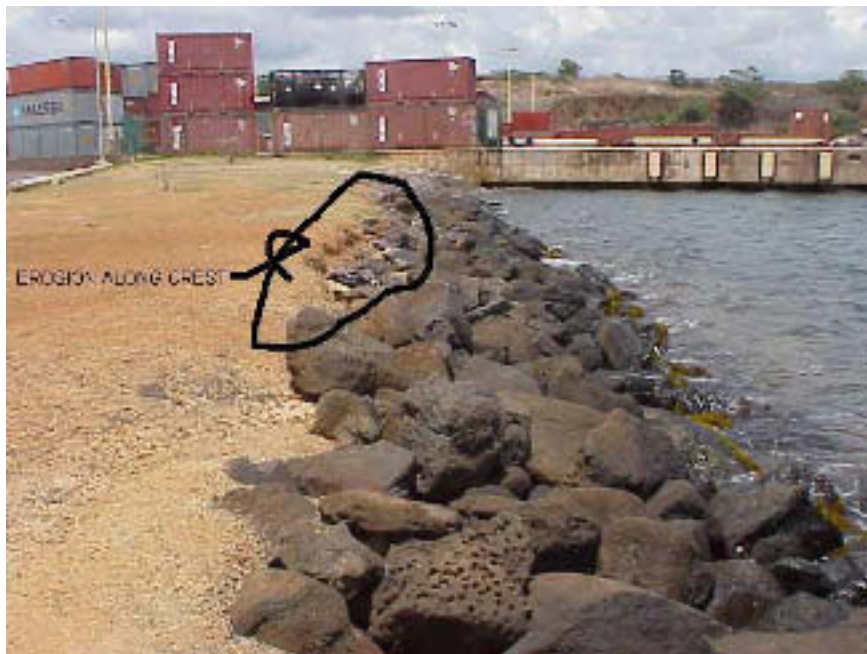
b. Sta 0+50 to 2+00: Erosion along crest.

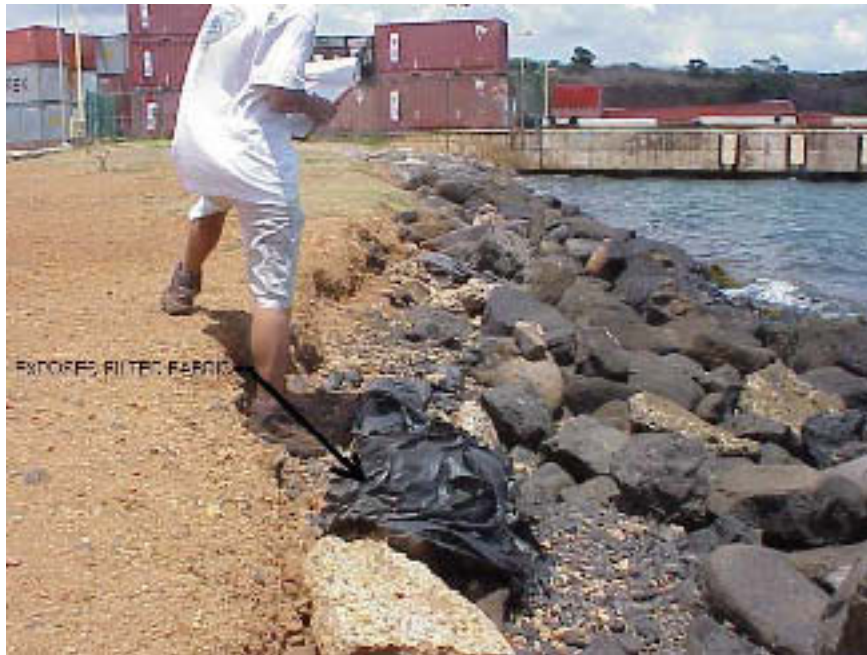
c. Sta. 1+50: Filter fabric at crest is exposed. Coral rock bedding is emptying out.

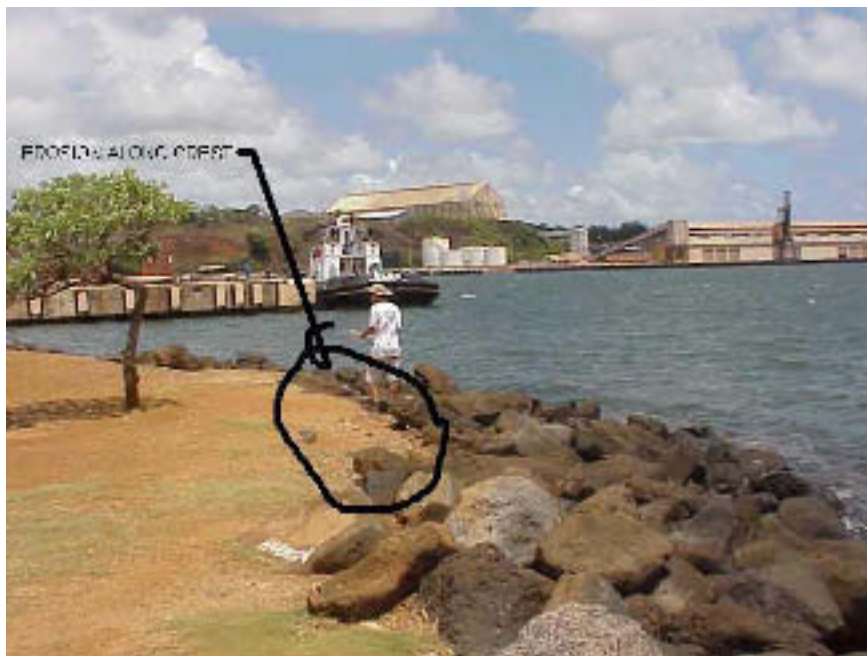
d. Sta. 2+00: Erosion along crest.

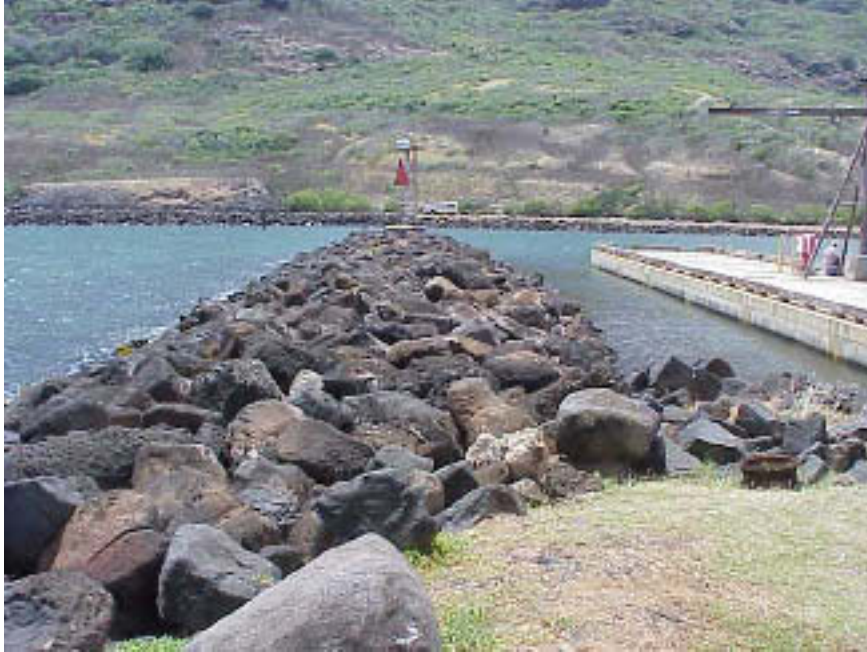
e. Sta 3+92: Stub overview to end. Herbicide mangroves and other vegetation. Action required by Army Corps of Engineers.

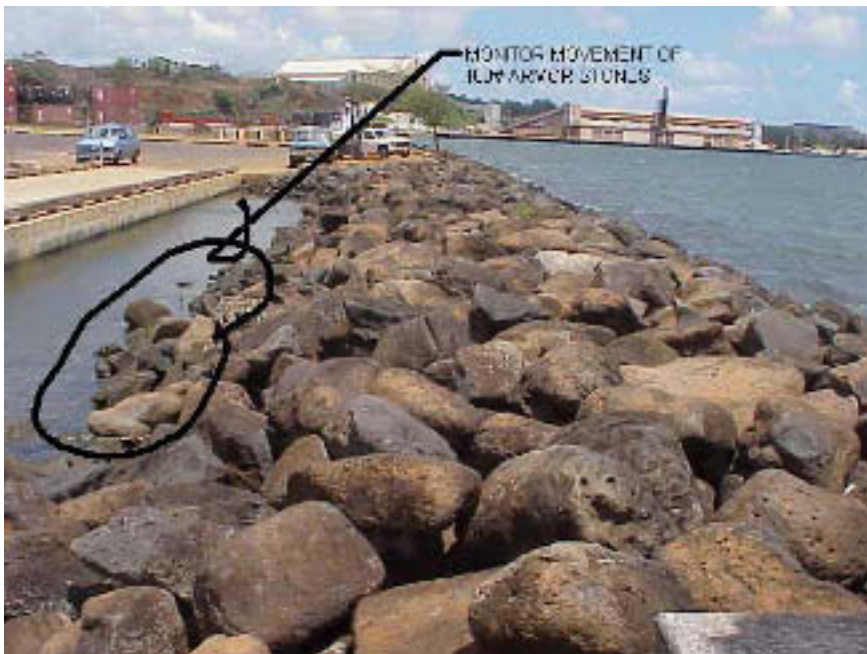
f. Sta 4+86: HS, monitor movement of 100# armor stones at toe.

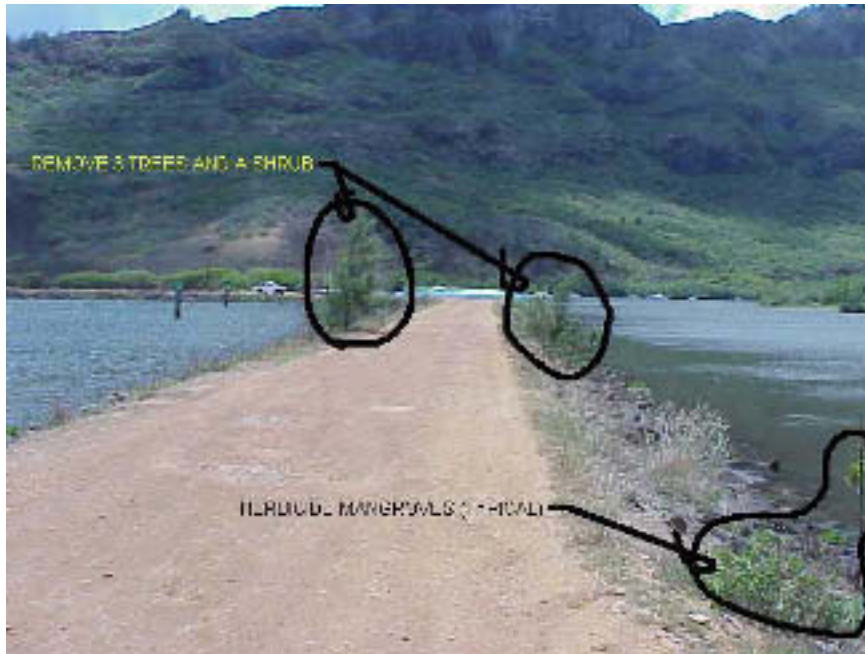
b. Sta. 3+95: Overview. Herbicide mangroves and other vegetation. Remove three (3) trees and a shrub.

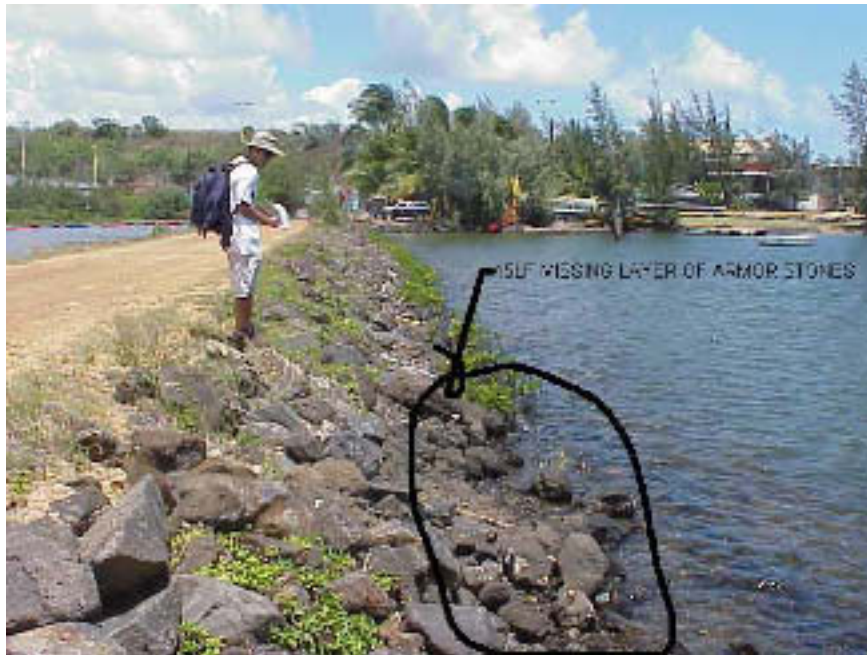
d. Sta. 7+00, HS, 15 LF missing armor layer at the waterline. Monitor (possible undersized stones @ construction).

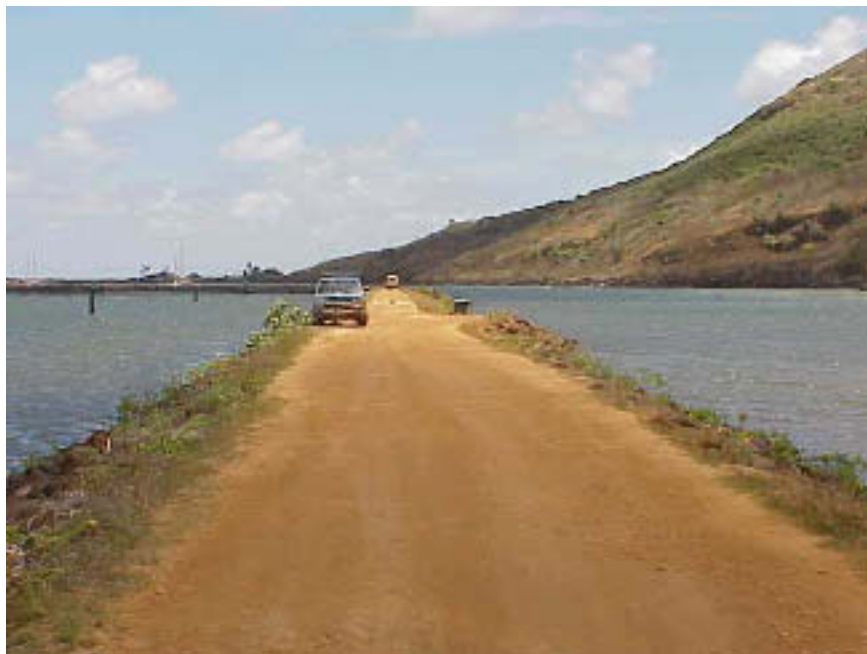
e. Sta 9+00: Overview to end. Again eliminating public vehicular traffic will retard erosion at the crest.
